**2016 Data Report
for
Stony Lake, Oceana County**

Site ID: 640049

Stony Lake, Oceana County 2016 CLMP Results

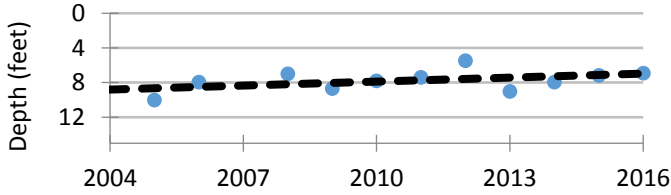
Secchi Disk Transparency (feet)

Year	# Readings	Min	Max	Average	Std. Dev	Carlson TSI
2016	16	3.5	11.0	6.9	2.1	49
2011-2015	111	2.0	14.0	7.4	1.9	48
2004-2010	128	1.5	19.0	8.3	2.8	47
2016 All CLMP Lakes	3116	1.0	56.0	12.9	2.8	41

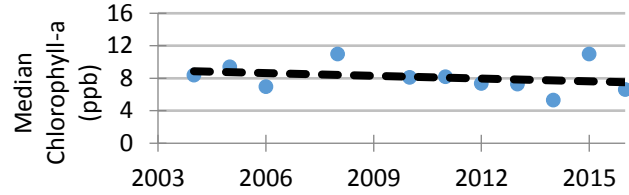
Chlorophyll-a (parts per billion)

Year	# Samples	Min	Max	Median	Std. Dev	Carlson TSI
2016	5	4.0	13.0	6.6	3.4	49
2011-2015	26	2.7	35.0	7.4	5.0	50
2004-2010	23	3.3	23.0	7.4	4.5	51
2016 All CLMP Lakes	628	<1.0	28.0	1.8	4.3	36

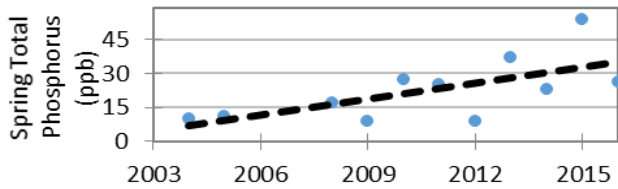
Spring Phosphorus (parts per billion)

Year	# Samples	Min	Max	Average	Std. Dev
2016	1	26.0	26.0	26.0	NA
2011-2015	5	9.0	54.0	29.6	16.9
2004-2010	5	9.0	27.0	14.8	7.5
2016 All CLMP Lakes	168	<= 3	74.0	9.5	7.8

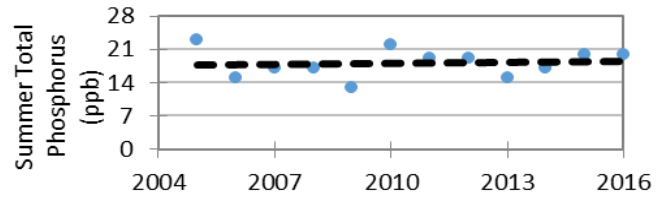
Summer Phosphorus (parts per billion)

Year	# Samples	Min	Max	Average	Std. Dev	Carlson TSI
2016	1	20.0	20.0	20.0	NA	47
2011-2015	5	15.0	20.0	18.0	2.0	46
2005-2010	6	13.0	23.0	17.8	3.9	45
2016 All CLMP Lakes	173	<= 3	250.0	15.1	21.7	43

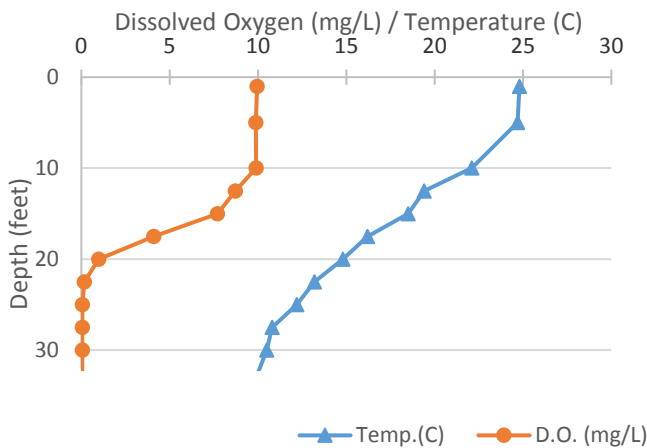
Dissolved Oxygen and Temperature Profile 7/13/2016

The lake keeps some dissolved oxygen in the bottom waters through early summer, but by mid-summer the lake has stratified and the bottom water is devoid of oxygen.

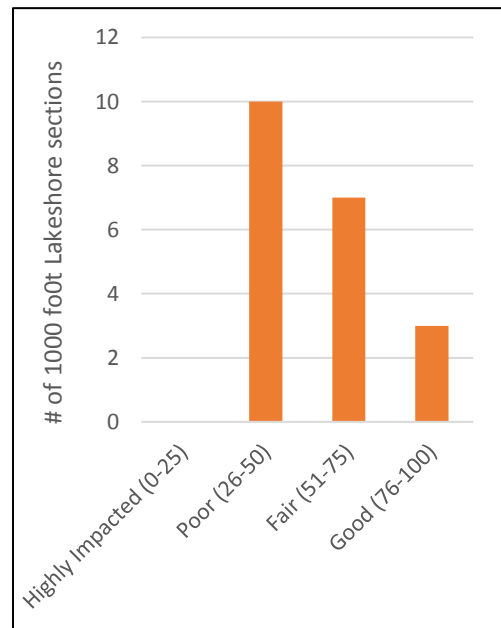
Stony Lake:	
Number of Sections:	40
Number of Structures:	312
Structure Density:	15.6
Final Score:	55

All 31 Participating Lakes in 2015 and 2016:	
Avg. Number of Sections:	16
Avg. Number of Structures:	233
Avg. Structure Density:	14.6
Avg. Final Score:	66

There is a very tight relationship between Final Score and Structure Density. It will be interesting to see if and how this changes as more lakes go through this scoring process.

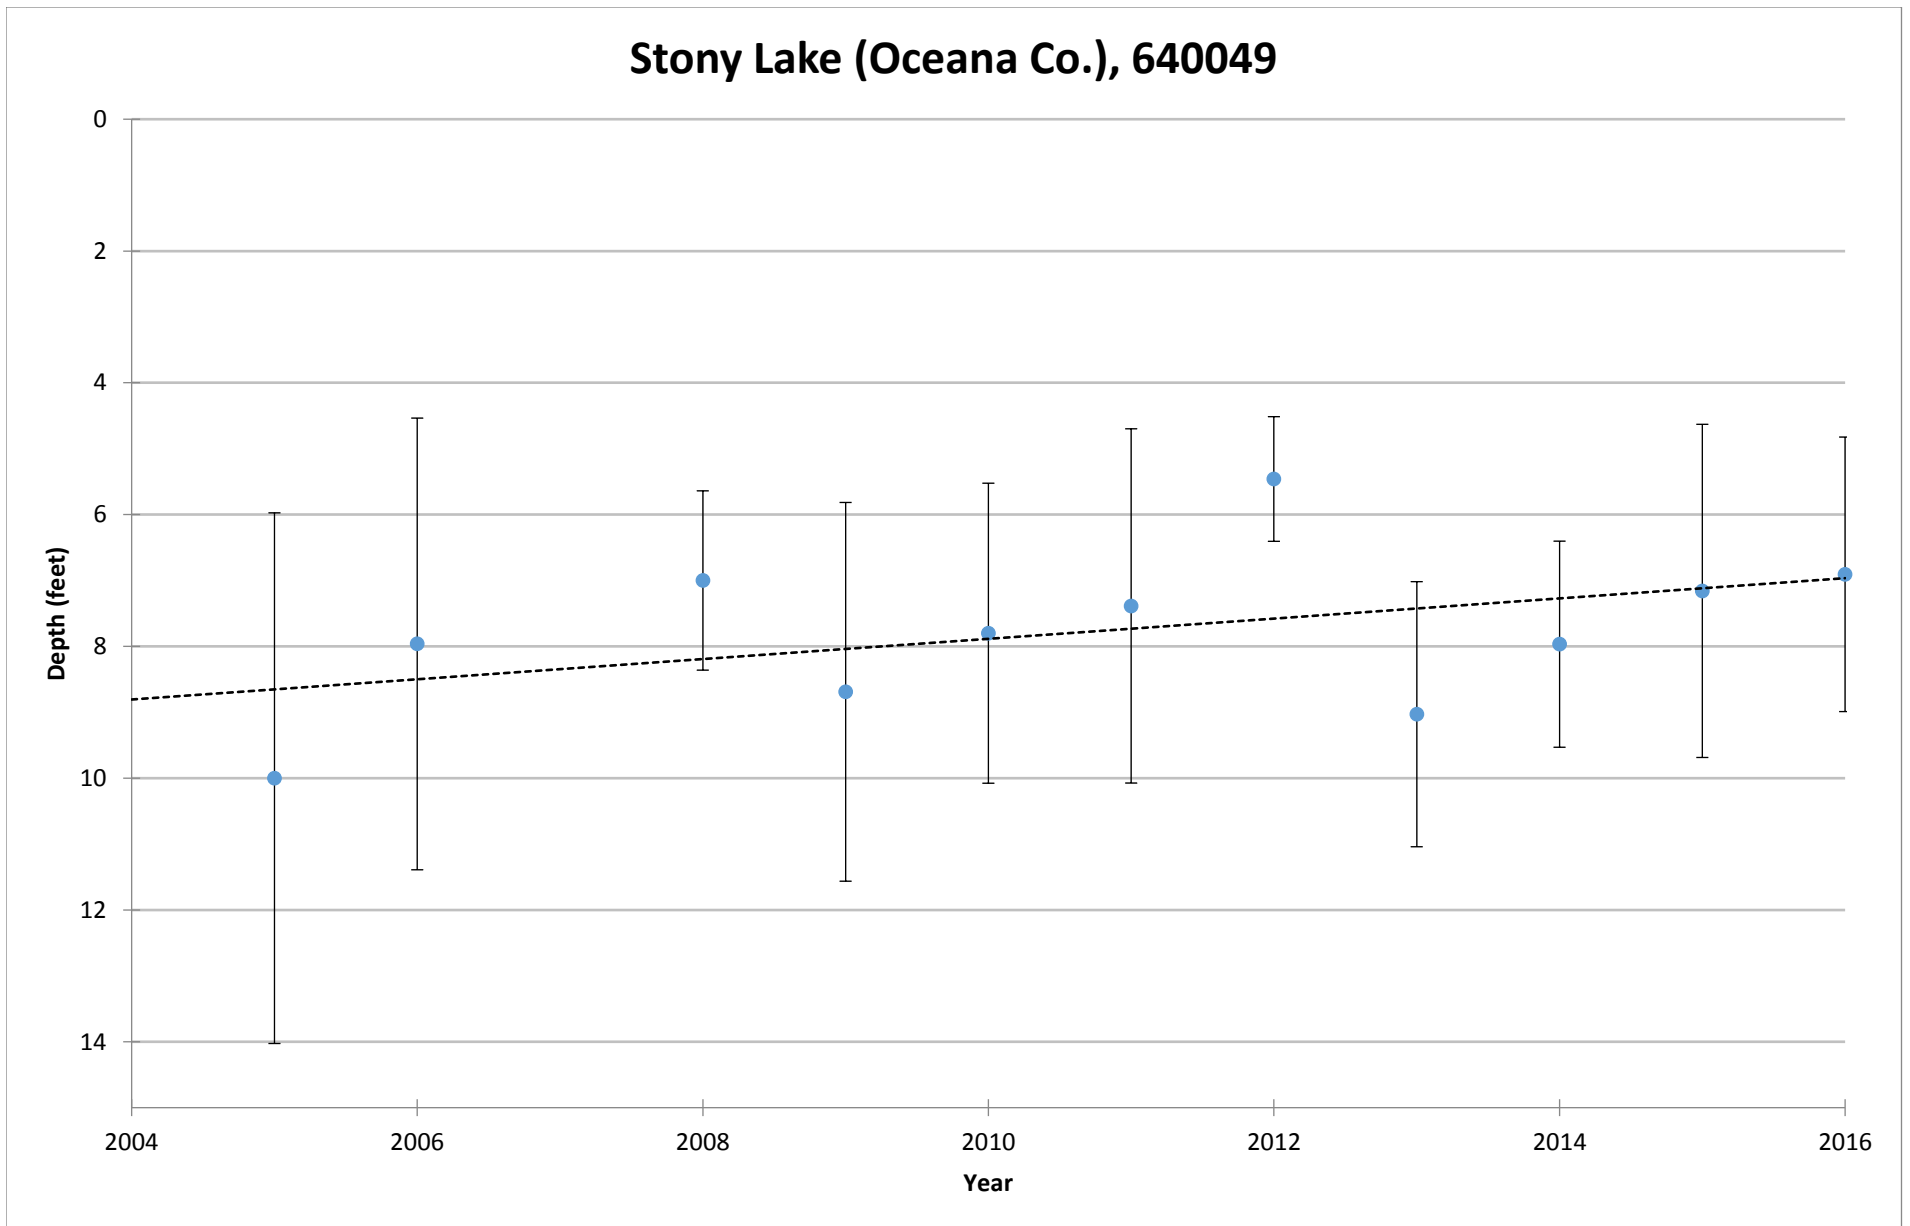
Stony Lake (Oceana Co.), 640049

COOPERATIVE LAKES MONITORING PROGRAM
SUMMER MEAN TRANSPARENCY

Vertical bars indicate standard deviation

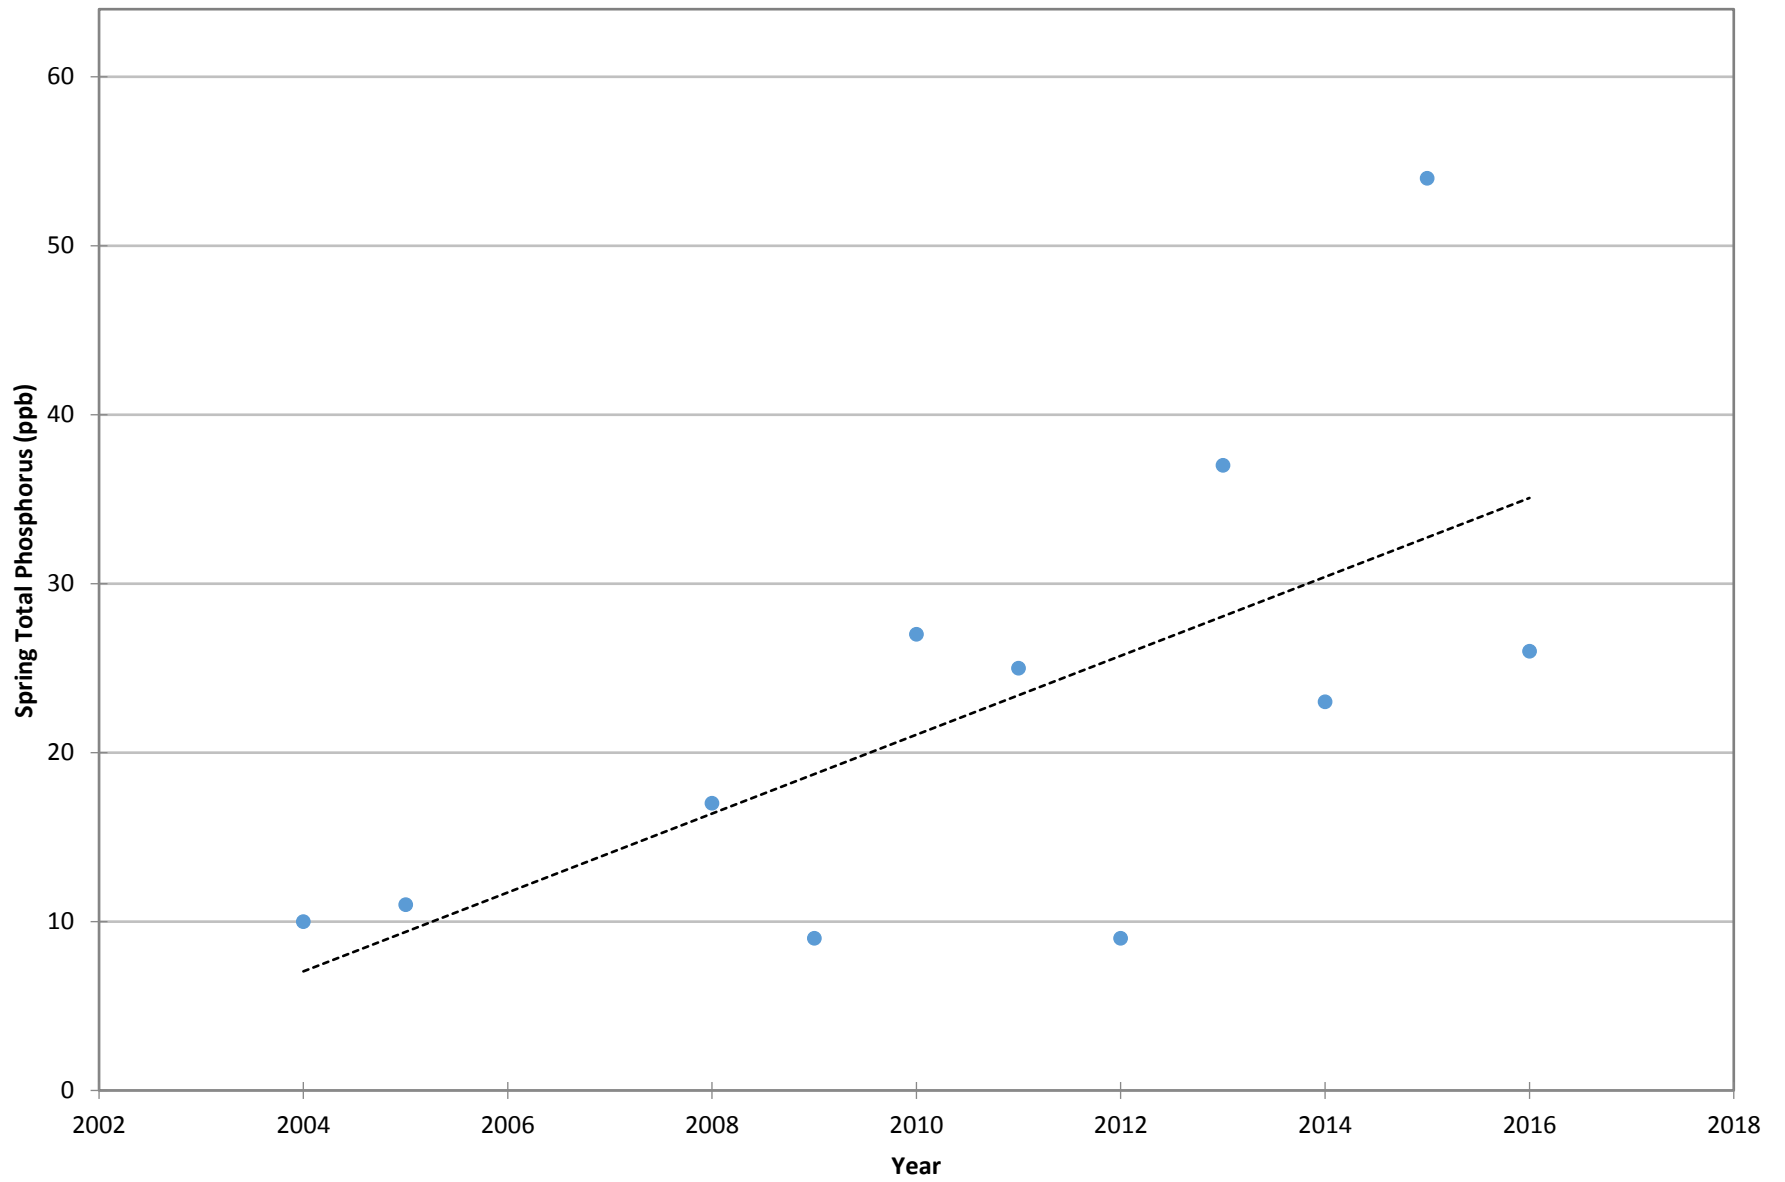
Stony Lake (Oceana Co.), 640049

COOPERATIVE LAKES MONITORING PROGRAM
SPRING TOTAL PHOSPHORUS

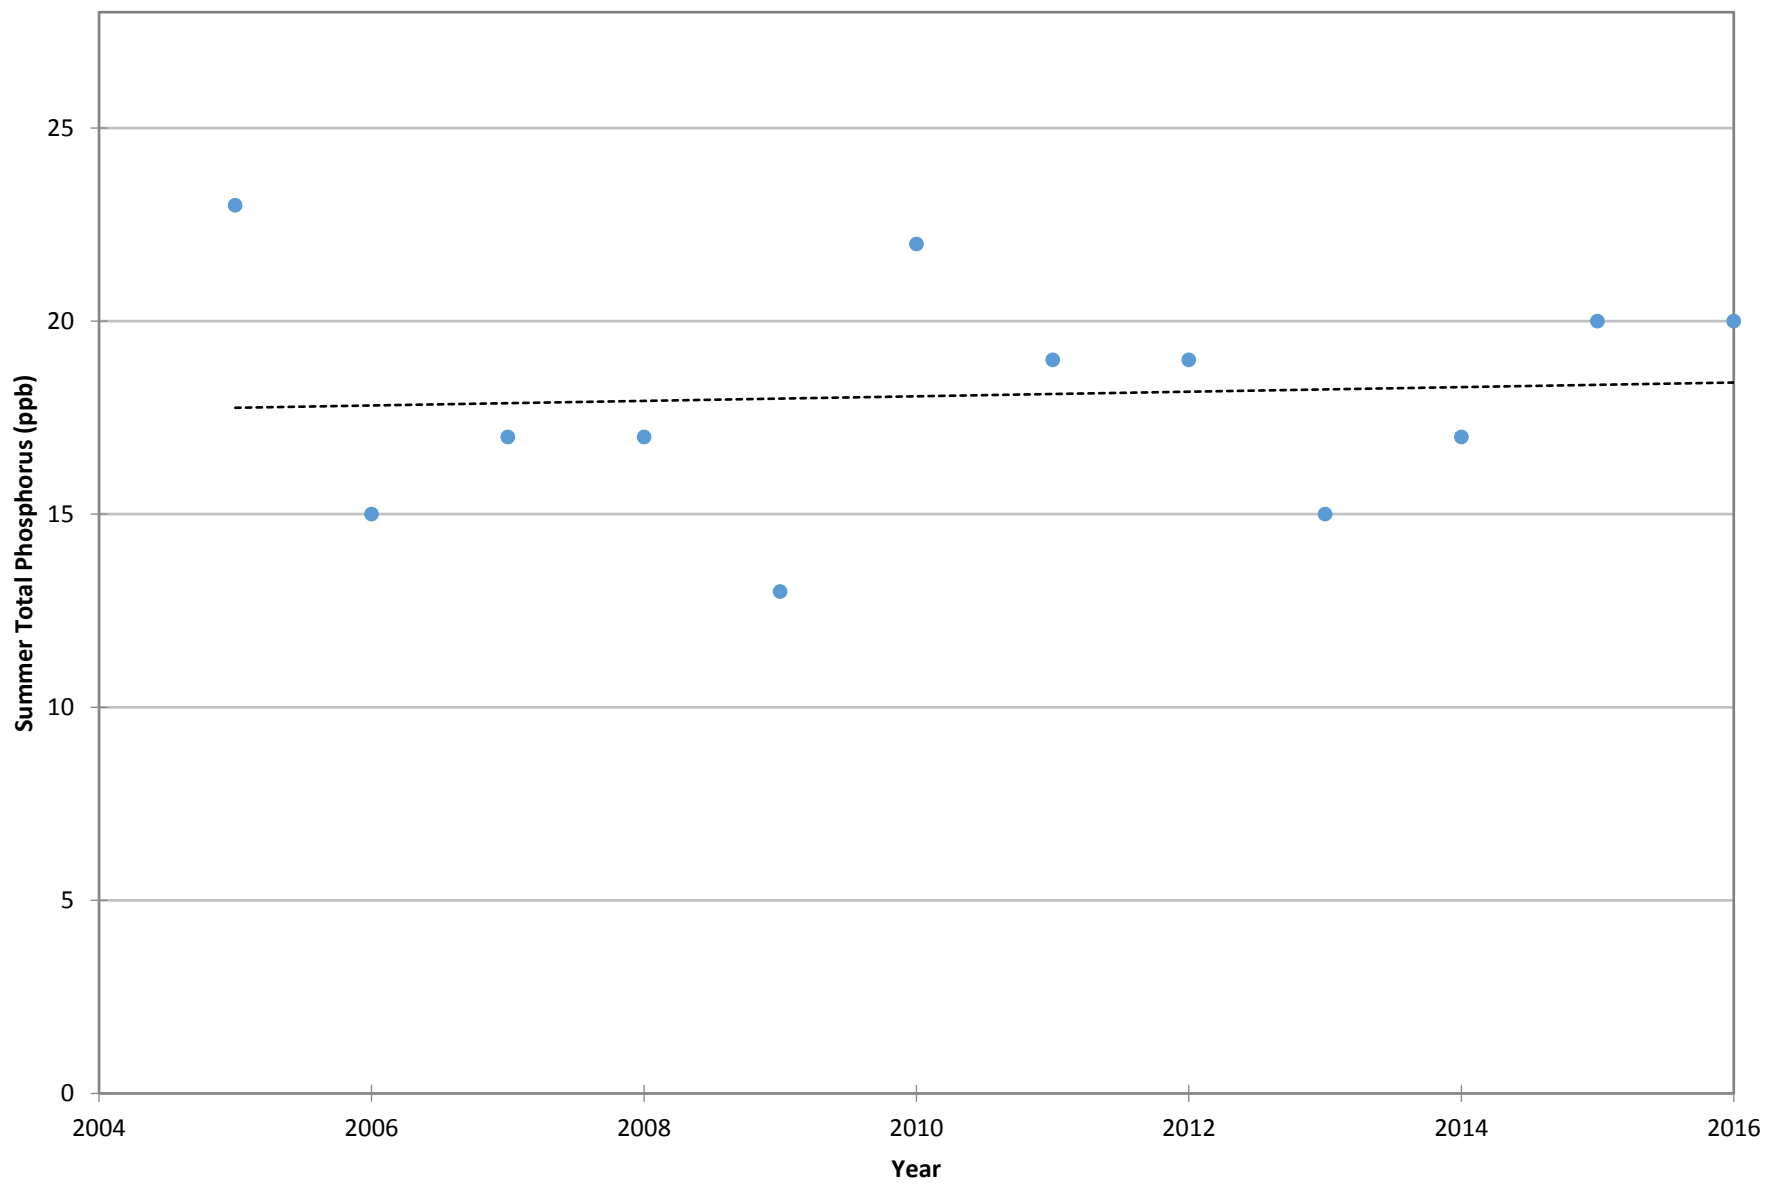
Stony Lake (Oceana Co.), 640049

COOPERATIVE LAKES MONITORING PROGRAM
SUMMER TOTAL PHOSPHORUS

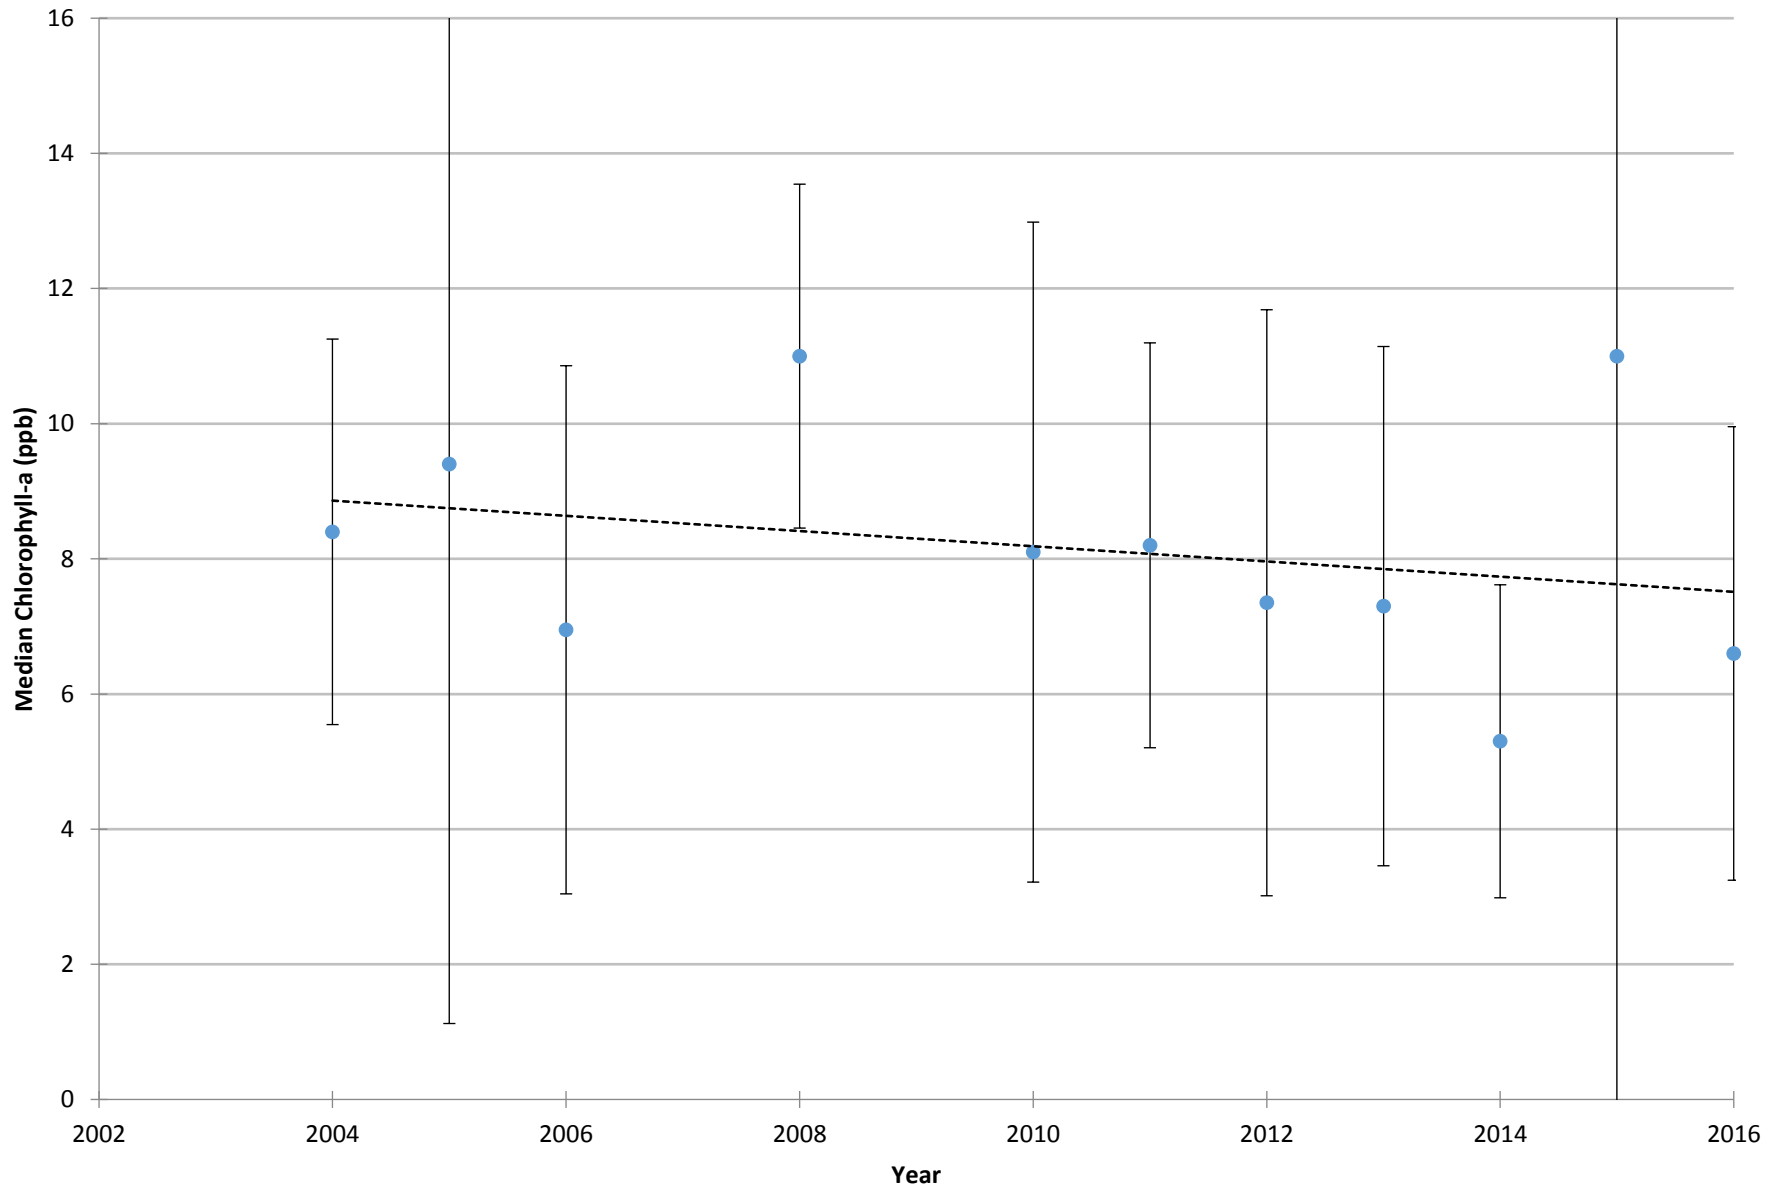
Stony Lake (Oceana Co.), 640049

COOPERATIVE LAKES MONITORING PROGRAM
SUMMER MEDIAN CHLOROPHYLL-A

Vertical bars indicate standard deviation

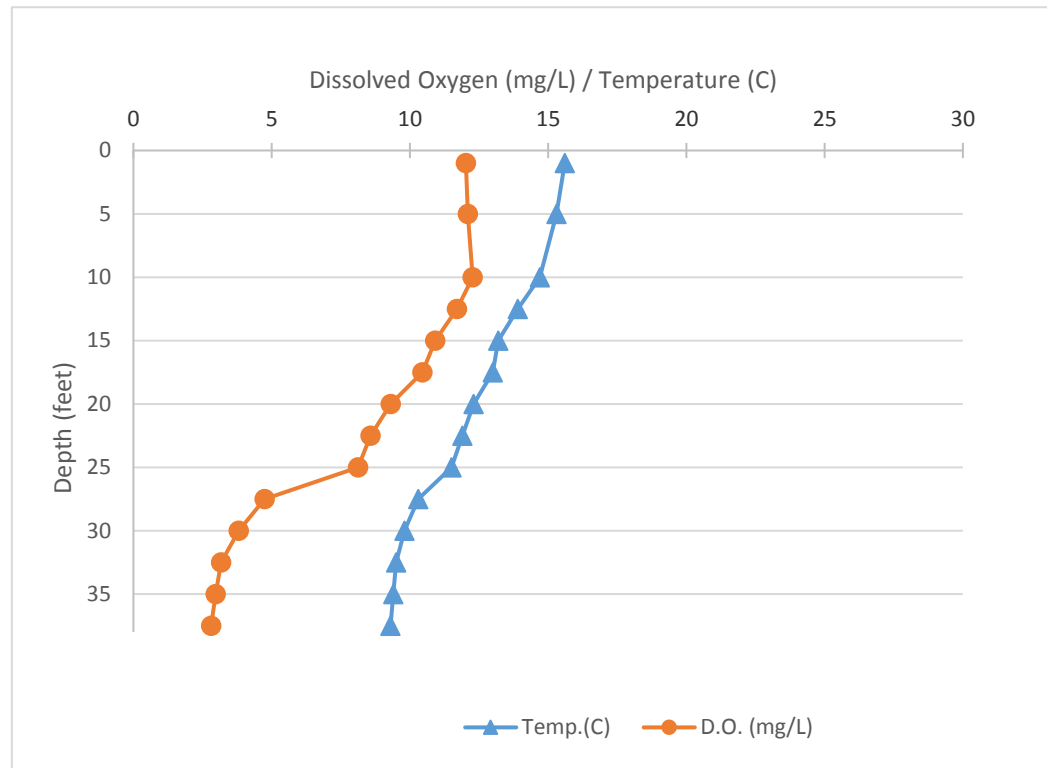
Name: Stony Lake
County: Oceana
Site ID: 640049
Date: 5/20/2016

Dissolved Oxygen and Temperature Profile

Depth (ft)	Temp.(C)	D.O. (mg/L)
1	15.6	12.03
5	15.3	12.1
10	14.7	12.27
12.5	13.9	11.7
15	13.2	10.92
17.5	13	10.45
20	12.3	9.31
22.5	11.9	8.58
25	11.5	8.12
27.5	10.3	4.75
30	9.8	3.81
32.5	9.5	3.17
35	9.4	2.98
37.5	9.3	2.81

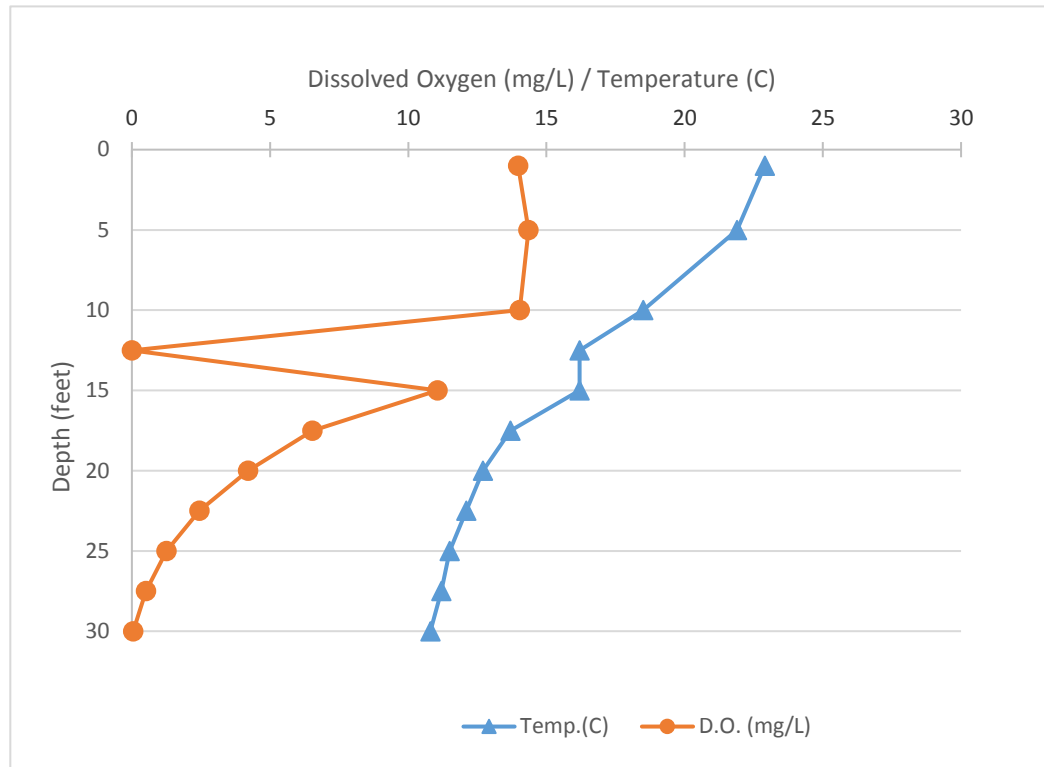
Name: Stony Lake
County: Oceana
Site ID: 640049
Date: 6/17/2016

Dissolved Oxygen and Temperature Profile

Depth (ft)	Temp.(C)	D.O. (mg/L)
1	22.9	13.98
5	21.9	14.35
10	18.5	14.03
12.5	16.2	0
15	16.2	11.06
17.5	13.7	6.53
20	12.7	4.2
22.5	12.1	2.44
25	11.5	1.25
27.5	11.2	0.51
30	10.8	0.05

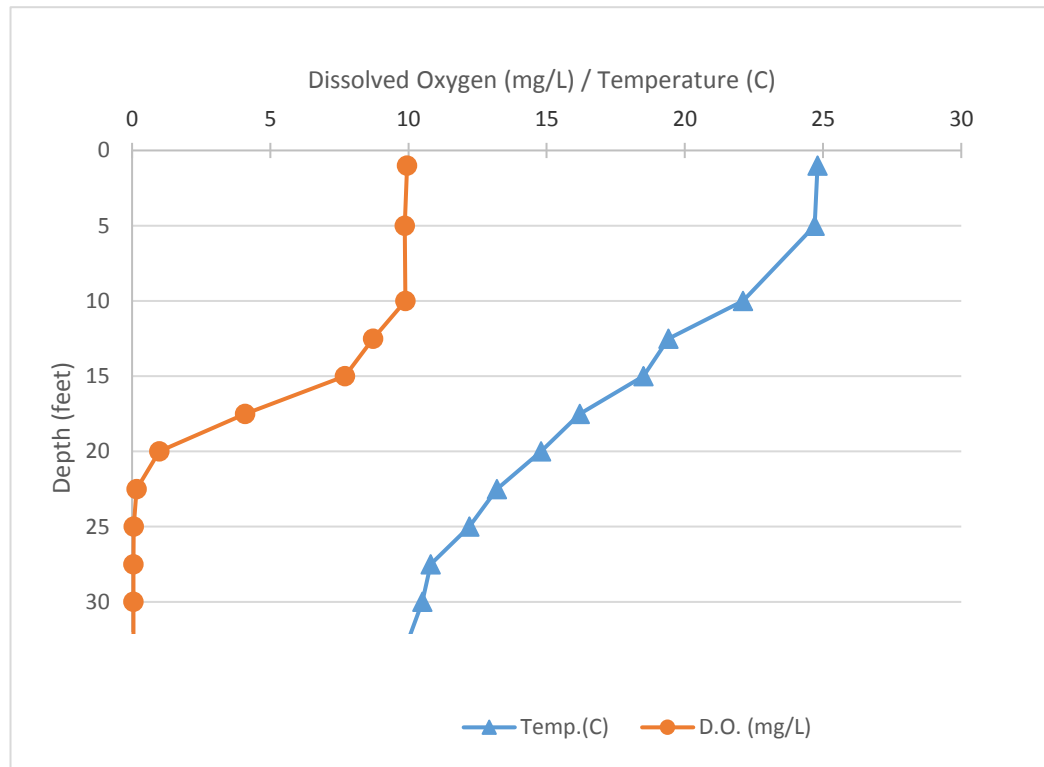
Name: Stony Lake
County: Oceana
Site ID: 640049
Date: 7/13/2016

Dissolved Oxygen and Temperature Profile

Depth (ft)	Temp.(C)	D.O. (mg/L)
1	24.8	9.95
5	24.7	9.87
10	22.1	9.89
12.5	19.4	8.72
15	18.5	7.7
17.5	16.2	4.09
20	14.8	0.99
22.5	13.2	0.16
25	12.2	0.06
27.5	10.8	0.05
30	10.5	0.05
32.5	10	0.05

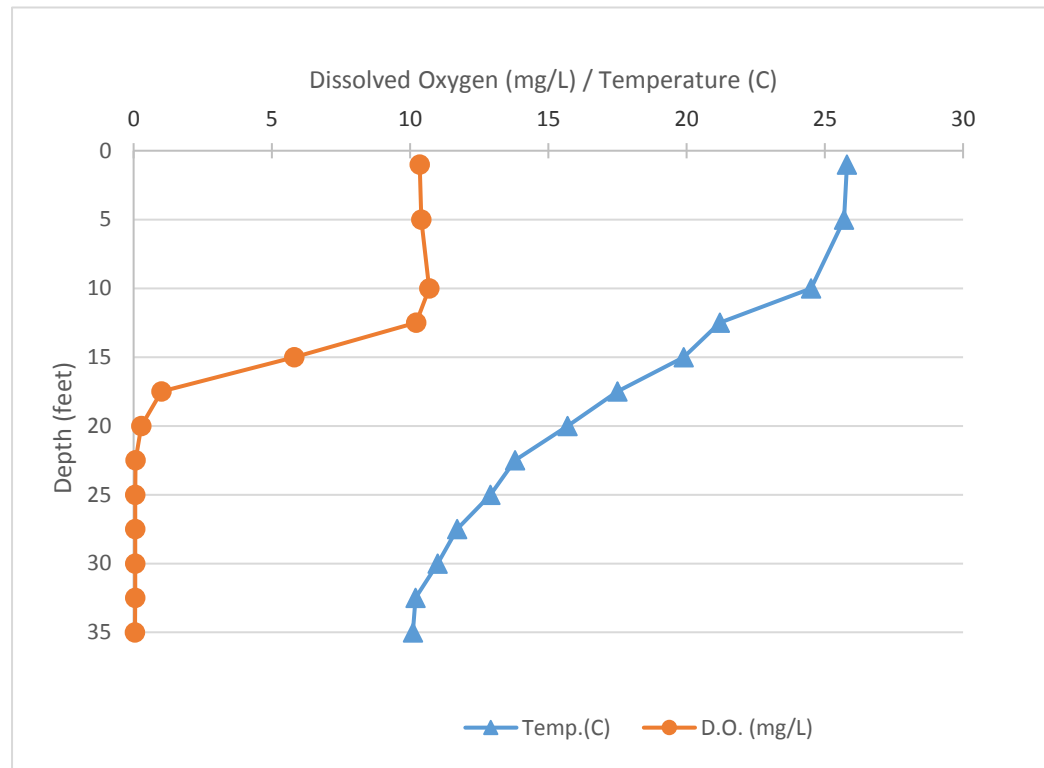
Name: Stony Lake
County: Oceana
Site ID: 640049
Date: 7/29/2016

Dissolved Oxygen and Temperature Profile

Depth (ft)	Temp.(C)	D.O. (mg/L)
1	25.8	10.35
5	25.7	10.41
10	24.5	10.69
12.5	21.2	10.22
15	19.9	5.81
17.5	17.5	1.01
20	15.7	0.28
22.5	13.8	0.07
25	12.9	0.06
27.5	11.7	0.06
30	11	0.06
32.5	10.2	0.06
35	10.1	0.05

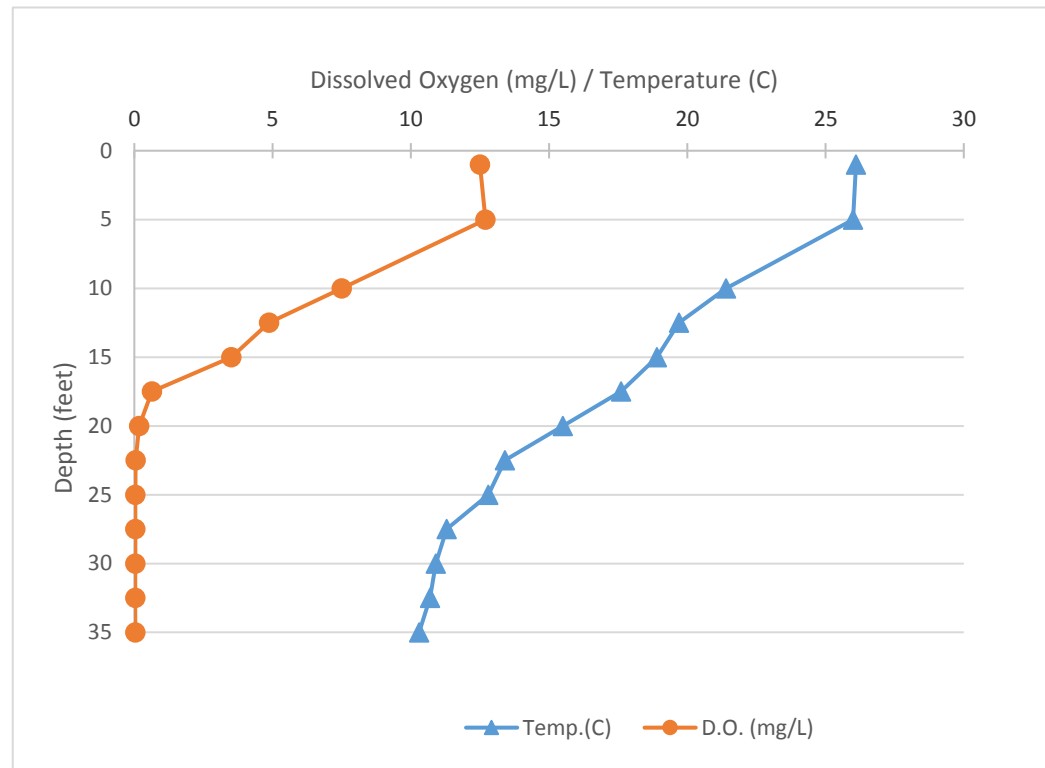
Name: Stony Lake
County: Oceana
Site ID: 640049
Date: 8/15/2016

Dissolved Oxygen and Temperature Profile

Depth (ft)	Temp.(C)	D.O. (mg/L)
1	26.1	12.5
5	26	12.7
10	21.4	7.5
12.5	19.7	4.87
15	18.9	3.51
17.5	17.6	0.64
20	15.5	0.17
22.5	13.4	0.05
25	12.8	0.04
27.5	11.3	0.04
30	10.9	0.04
32.5	10.7	0.03
35	10.3	0.04
